# **DESCHUTES BASIN HABITAT CONSERVATION PLAN STUDY REPORT**

## **Study 14: Assessment of Fish Passage and Screening at Diversions Covered by the DBHCP – Phase 1**

**Deschutes Basin Board of Control, and  
City of Prineville, Oregon**

**Biota Pacific Environmental Sciences, Inc.  
And  
R2 Resource Consultants, Inc.**

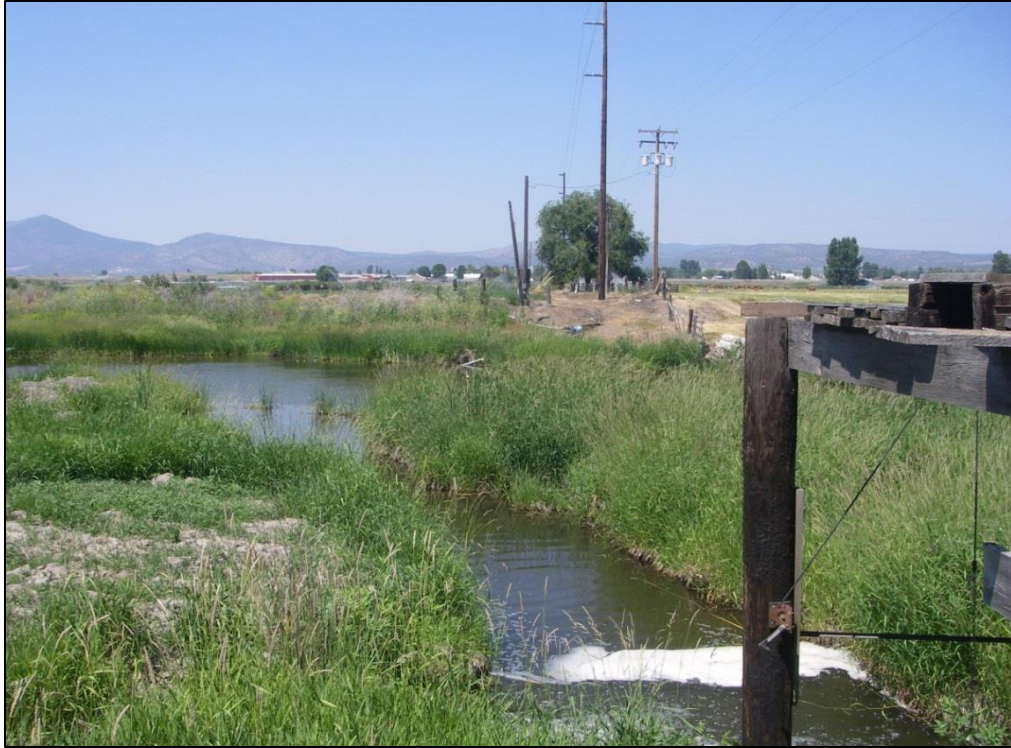
The intake is located at the terminal end of a dead-end excavated channel (Figure 2-7) with a temporary vertical flat-plate fish screen blocking the inlet canal to the pump. The passive screen is a 4-foot by 8-foot panel with 3/32-inch screen mesh that guards the channel leading from the Crooked River to the pump (Figure 2-8). The removable screen is designed to mechanically drop into grooved side slots for a rigid, perpendicular orientation to the inlet channel. However, the screen is only a partial deterrent to fish exclusion, since the rectangular structure does not completely block the sides or the bottom of the channel. The screen has no sweeping velocity, no fish bypass, and no cleaning capability (other than removing it for cleaning). The screen does not comply with NFMS criteria for fish passage facilities.

**Figure 2-7. City of Prineville inlet channel from the Crooked River at RM 45.9.**

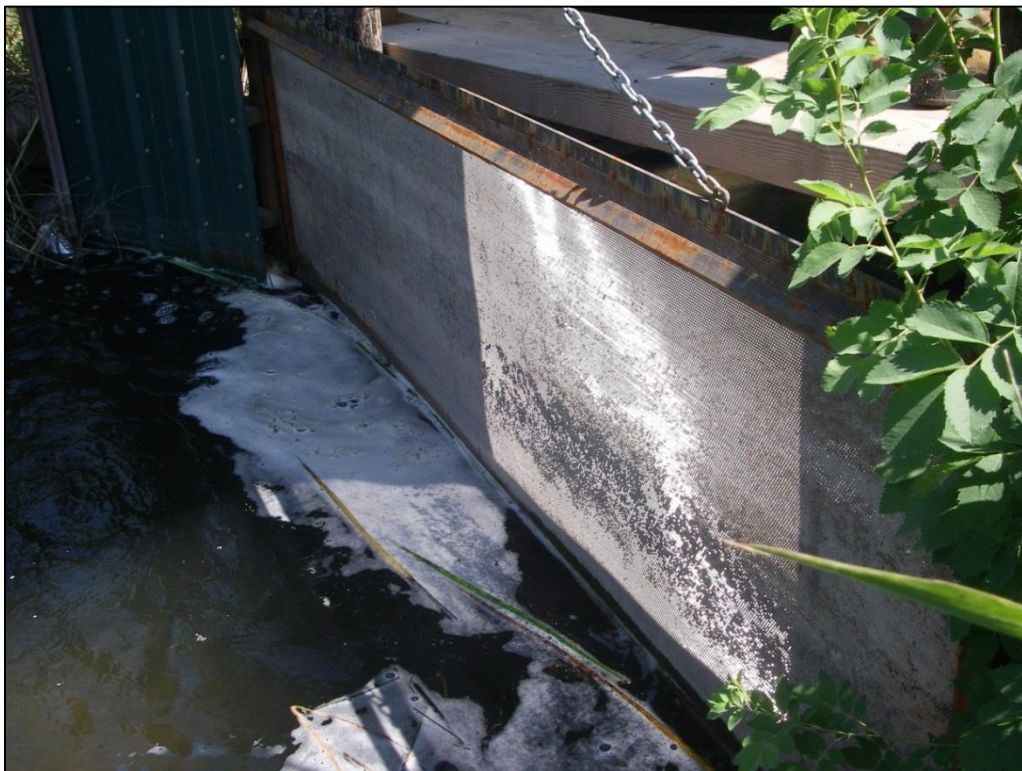
**Figure 2-8. City of Prineville vertical plate fish screen.**

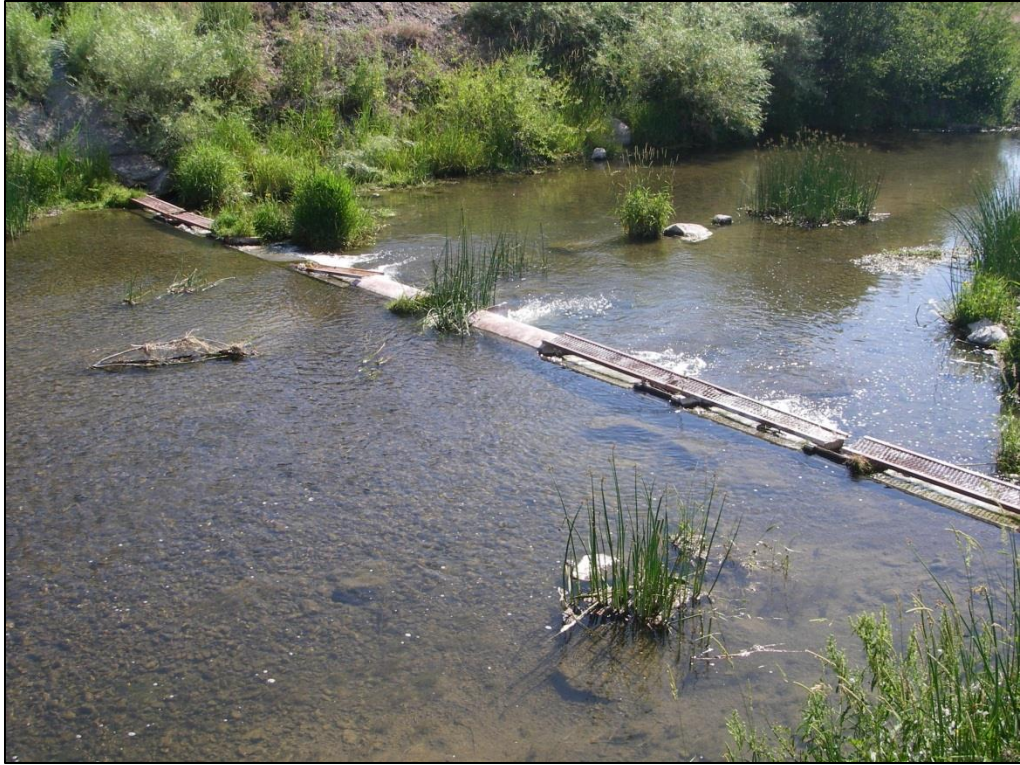
As described in Appendix A, the Breese Diversion was constructed and authorized by the state in accordance with available biological criteria existing in the late 1990s. Acceptance of ongoing operations falls under the existing screen criteria (§11.4 of the 2011 NMFS criteria). Other than one bent screen that requires repair, and the location of the intake near potential spawning and incubation habitats, the screens comply with the categorical approvals NMFS established for existing screens.

A comparison was also performed to assess how the current screen conditions would perform against the criteria for construction of new horizontal flat-plate screens. NMFS views the horizontal screens as experimental technology because they operate fundamentally different from conventional vertically-oriented screens. The Breese screens complied with the criteria and guidelines for: 1) *Site Limitations* (V-notch; fish passage; channel approach); 2) *Bypass Flow Amount* (more than 50% of diverted water); 3) *Diversion Shut-off* (V-notch); 4) *Approach Velocity* (maximum instantaneous design capacity < 0.25 fps); and 5) *Screen Materials* (smooth, corrosion resistant, durable surfaces, % open areas > 27%). The Breese intake screens would not likely comply with criteria and guidelines for: 1) *Screen Materials* (circular openings < 3/32 inch); 2) *Sweeping Velocity* (> 2.5 fps, and steady velocities across the screen face); 3) *Self-cleaning Screens* (sweeping to approach velocity ratio of > 20:1); and 4) *Monitoring Requirements*. It is unknown if the operation of the Breese Diversion would comply with NFMS criteria for *Sediment Removal* requirements.

**Figure 2-9. Breese diversion structure in Ochoco Creek.**

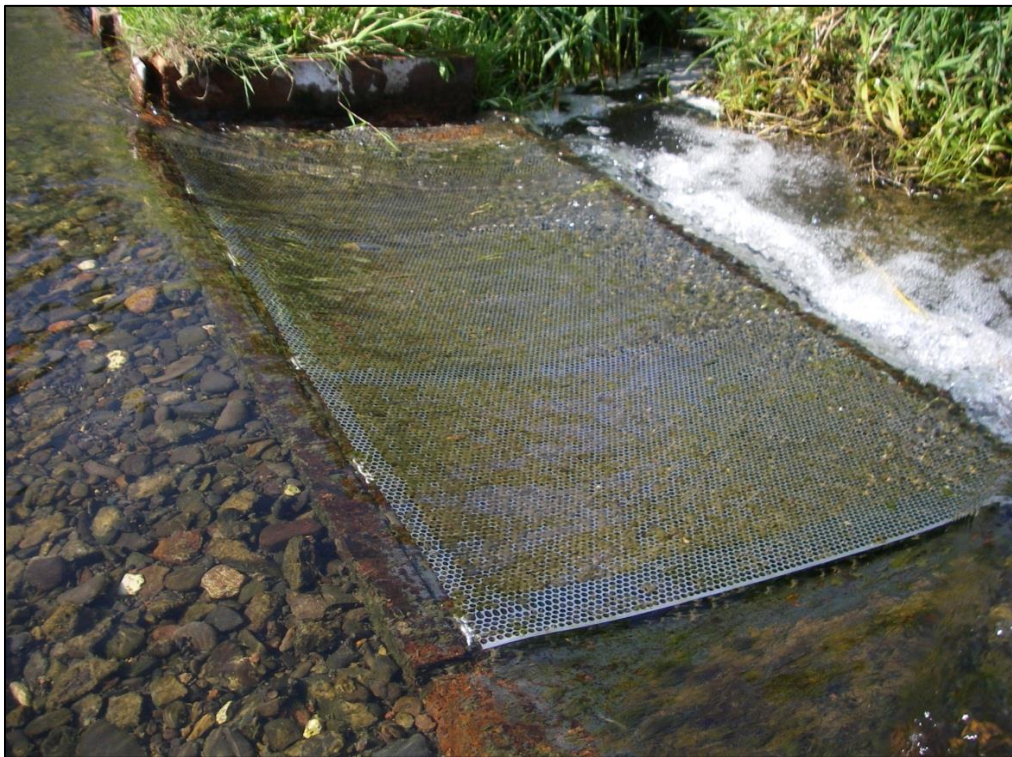
**Figure 2-10. Breese horizontal perforated screen surface.**

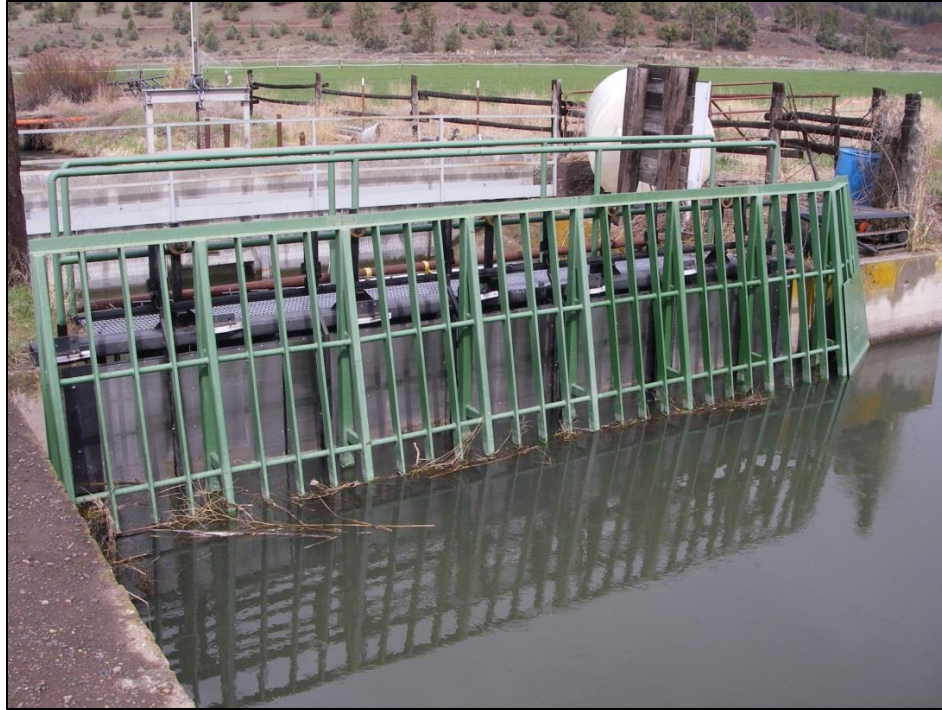
**Screens:** The headgate to the canal is screened to exclude fish (Figure 2-11). The screens were designed and built by ODFW in 2001 to comply with NMFS screen criteria under a maximum design flow of 40 cfs (ODFW 2012b). The screens include 8-inch vertical bar trash racks in front of three rows of five, nearly 2-foot x 4-foot screen panels consisting of stainless steel 3/32-inch perforated plates. The maximum screen area is 114 feet<sup>2</sup>. At the maximum 6-foot screen depth, the normal design approach velocity at 40 cfs would be 0.35 fps. The screen panels are mechanically cleaned with roller wiper assembly of screen brushes.

**Figure 2-11. Fish exclusionary screens in the Ochoco Main Canal at Jones Siphon crossing.**

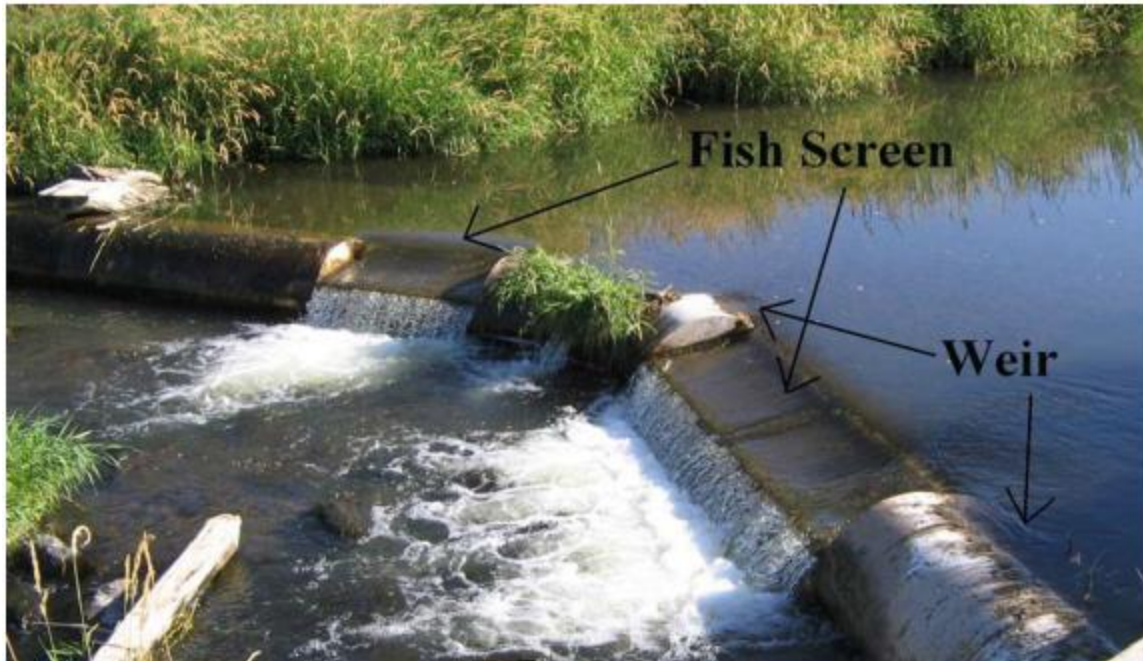
The USGS evaluated the weir and found the screen had average sweeping velocities of 3.2 to 4.7 fps, within the design diversion range of the weir and the range of streamflows observed during the 2004 and 2005 irrigation seasons (Rose et al. 2005). The mean sweeping velocities were found to be inversely related to the screen : weir ratio and directly related to stream flow. The low screen : weir ratio of 23 percent for the Smith Inverted Weir had relative high mean sweeping velocities. Approach velocities were not measured in the field, but can be calculated based on the maximum withdrawal rate divided by the effective screen area. The design capacity of 4 cfs for the diversion results in an average approach velocity over three screens of 0.21 fps.

Rose et al. (2005) noted that manual cleaning at intervals of 1 to 6 days was necessary to keep the screens free of debris. According to the authors, the inverted weir screens accumulated debris at about 5 percent of the screen area per day. The OID ditch riders clean the screens daily during the irrigation season. NMFS found the self-cleaning ability of a horizontal screen is enhanced when the ratio of sweeping velocity and approach velocity exceeds 20:1 (NMFS 2011). The sweeping to approach velocity ratio at Smith ranged between 4:1 and 6:1 at the maximum design capacity of the diversion. These levels are below the NMFS guidelines for self-cleaning of floating debris past the screens. Attached algae, periphyton, and stream debris continue to require daily physical cleaning. A withdrawal rate at the Smith diversion of 4.8 cfs or less would comply with NMFS most recent approach velocity criteria of 0.25 fps for horizontal flat plate screens on inverted weirs (NMFS 2011).

**Figure 2-12. Smith Inverted Weir and horizontal flat plate fish screens in McKay Creek.**

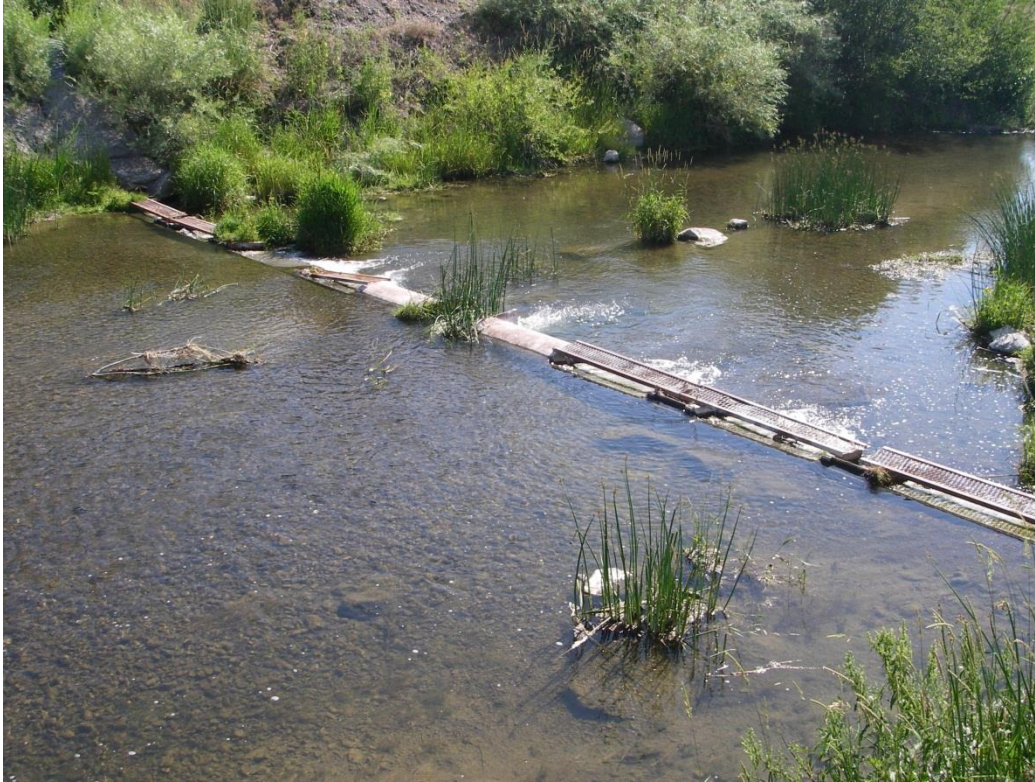
The sweeping velocity (SV) across the upper edges of all eight screens was measured between 1.2 and 2.9 fps and averaged  $2.0 \pm 0.4$  fps at a stream discharge of 15.9 cfs in Ochoco Creek. Sweeping velocities decreased approximately 40 percent across the screen face, with SVs along the downstream edge of the screens ranging between 0.0 and 2.8 cfs while averaging  $1.2 \pm 0.8$  cfs. For inverted weir structures, Rose et al. (2005) found sweeping velocities directly related to stream discharge and inversely related to the screen-to-weir ratio (linear length of the screens/linear length of the instream portion of the weir). For Breese, the screen-to-weir ratio was 55 percent. This ratio was nearly identical to the measured screen-to-weir ratio for the Ryegrass diversion further downstream in Ochoco Creek. Relatively high screen-to-weir ratios like for the Breese and Ryegrass diversions generally equates to lower SVs than for low screen-to-weir ratios like the Cook and Smith diversions in McKay Creek.

**Figure A-1. Breese Diversion in Ochoco Creek (RM 7.7) at 15.9 cfs.**

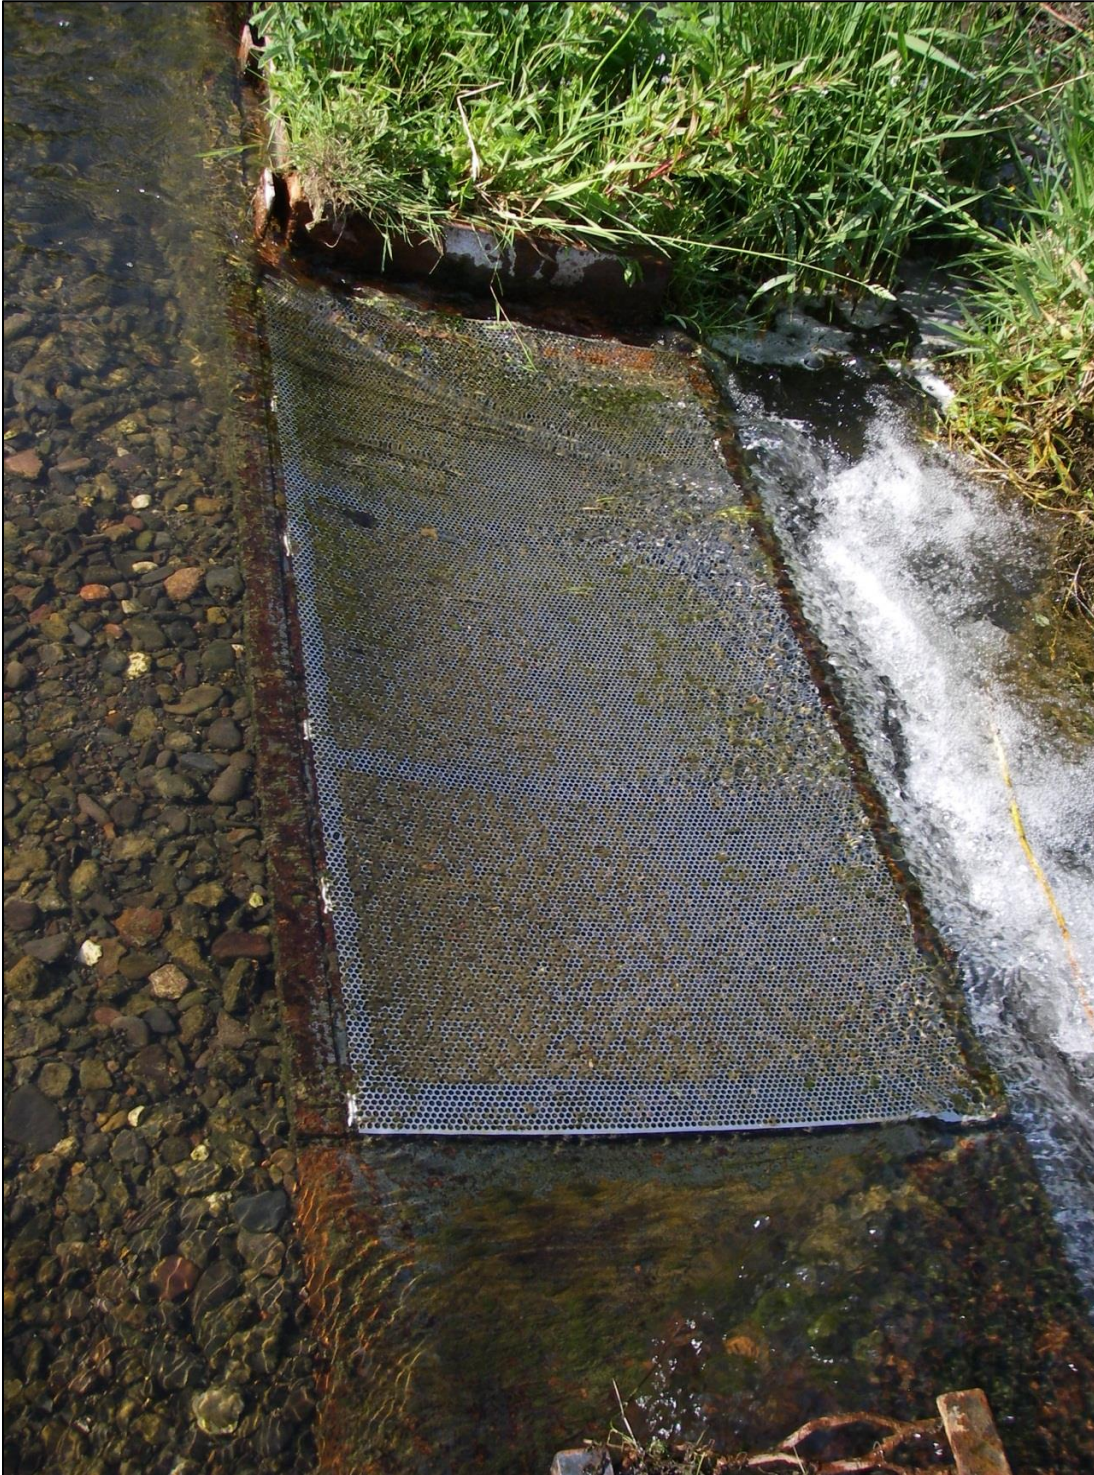
The OID ditch riders clean the Breese Diversion screens daily during the irrigation season. According to Rose et al. (2005), the inverted weir screen designs accumulated debris at about 5 percent of the screen area per day (Figure A-4). NFMS found the self-cleaning ability of passive horizontal screens is consistently achieved when the ratio of sweeping velocity and approach velocity exceeds 20:1 (NFMS 2011).

**Figure A-4. One-day accumulation of algal growth on Breese flat-plate screen surface.**
